Features of structure changing of copper wires in terms of the complex action of current and high temperature

Abstract. The article presents the results of researches changing the structure of copper wires internal electric networks under the action of electric and thermal loads. Described metallographic signs of short circuits in terms of the complex action of current and high temperature. On the basis of researches the features of the structure of electrical wires at different temperatures.

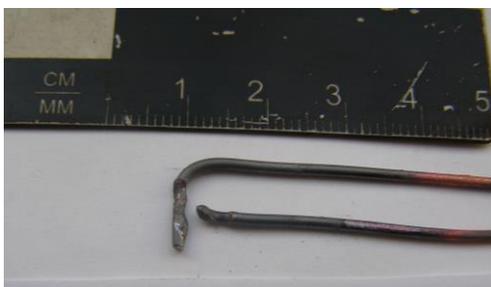
Fig. 5. Sample in which SC occurred at temperature 950°C 15 minutes to occurrence SC and removal from the furnace

After heating of wires to a temperature of 600, 800 and 950°C, SC is not accompanied by spraying, but it leads to substantial melting of the surface layers, as the presence of pits and areas indicates in which geometric parameters significantly different from the original form of wires (fig. 5).

This change of parameters of SC zone is connected with the dynamics of oxidation of the surface layers and with

change of the mechanical properties of the wires material at increased temperature. Heating above 400°C leads to softening of metal (modulus of elasticity (E) and ultimate tensile strength (σ_b) are reduced) so spraying does not occur.

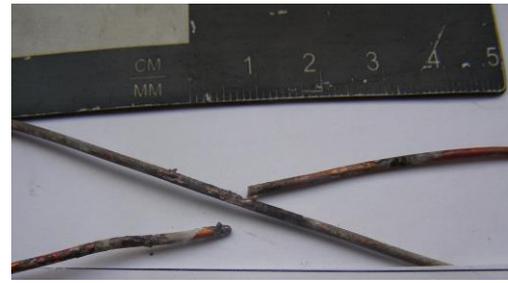
Analysis of the samples in which the SC took place under conditions close to real (using the model fire) showed that burnout of wire is possible not only in the area of contact of wires but also beyond its bounds. This is due to the higher resistance in the SC zone due to the action of flame, as the formation of a layer of dark color indicates on the surface fracture (fig. 6).

Fig. 6. Samples in which SC occurred as the result of damage of the insulation by flame
